4. TITLE (and Subtitle) Somerset Reservoir Dam  NATIONAL PROGRAM FOR INSPECTION OF NON-FEDERAL DAMS		5. TYPE OF REPORT & PERIOD COVERED INSPECTION REPORT

SOMERSET RESERVOIR DAM  
MA 00792

Somerset Reservoir was formed by an "intermediate" size dam build in 1965 to create an offstream water supply for the Town of Somerset. The dam consists of an earth embankment approximately 6700 ft. long with a maximum height of 45 ft. There is a small "emergency spillway" at the north end of the dam and two 20-in. outlet pipes from an intake tower in the reservoir. Somerset Reservoir is currently classified as having a "high" hazard potential in the Corps of Engineers National Inventory of dams.

PHASE I INVESTIGATION REPORT  
NATIONAL DAM INSPECTION PROGRAM  
SOMSERSET RESERVOIR DAM  
MA 00792

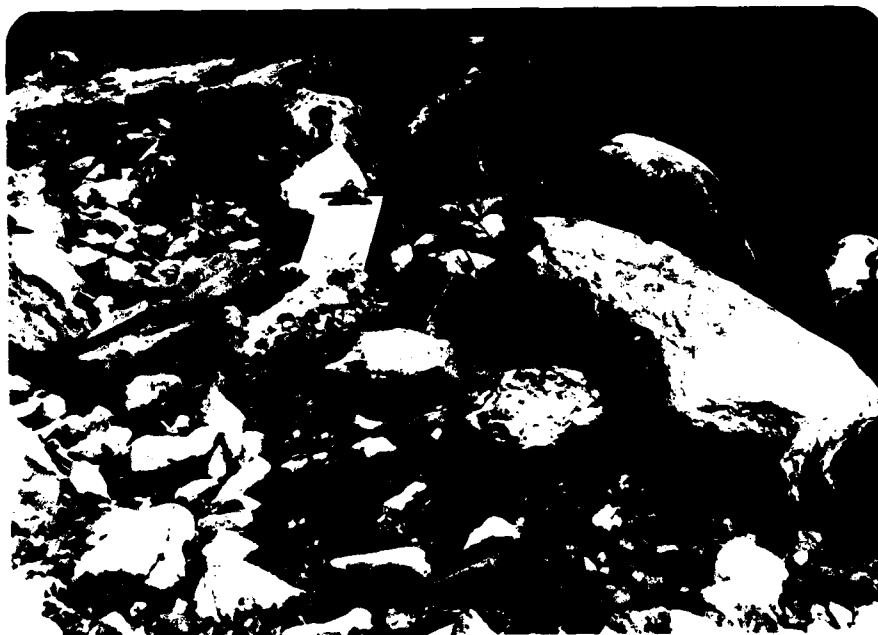
1. Riprap and screened gravel bedding have been eroded by wave action in localized areas, Photo No. 4. While repairs to the riprap are common in the vicinity of Sta. 35+00 to Sta. 50+00, Photo No. 3, other areas need attention to prevent progressive erosion.
2. Two areas of seepage on the downstream slope were noted. The first, and most important, is located in the vicinity of Sta. 9+00, Photos No. 5 and 6. The top of the wet area, in which cattails are growing, is approximately 8 ft. vertically above the berm. Water is ponded on the berm and the wet area extends to the toe of the embankment and beyond. No actual seepage flow, boils or erosion were observed.

4. Example of eroded section of riprap

Finally, recommendations for remedial work including clearing and mowing the downstream slope and emergency spillway and channel, repairing riprap in localized areas, replacing the abutment foundation for the access bridge to the intake tower and preparing formal plans for operation and maintenance to the dam and

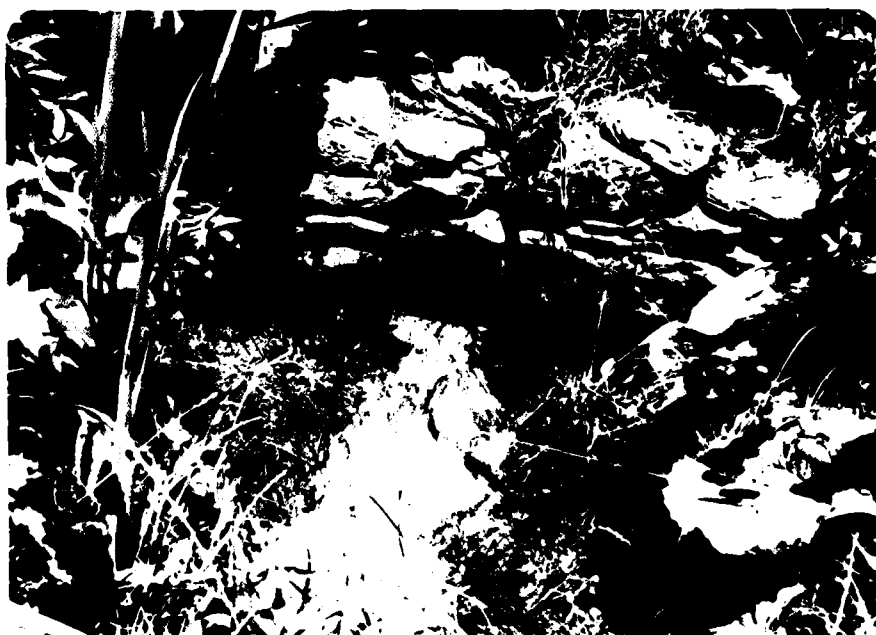
The core wall drains and toe drains discharge at two locations beyond the downstream toe of the dam, Sta. 10+00 and Sta. 42+00. At each location, a 10-in. porous wall concrete pipe flanked by two 6-in. porous wall pipes discharge at a stone headwall. All six pipes were flowing. Photo No. 8 shows the three pipes at Sta. 10+00 after weeds and grass were cleared. Photos No. 9 and 10 show the submerged drain pipes at Sta. 42+00 and a wet swampy area which occurs downstream of the point of discharge. Water discharging from the pipes was clear and cold except for floating flecks of rust-brown organic matter. This material has stained the invert of the pipe and the stream beds as shown on the photographs.

8. Outlet of embankment drain pipes, Sta. 10+00

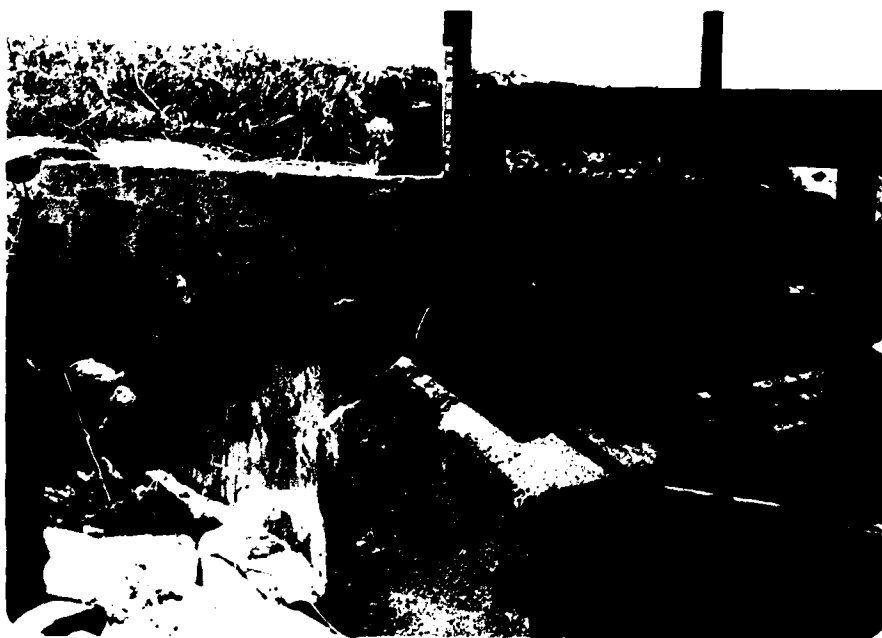
12. Abutment for access bridge

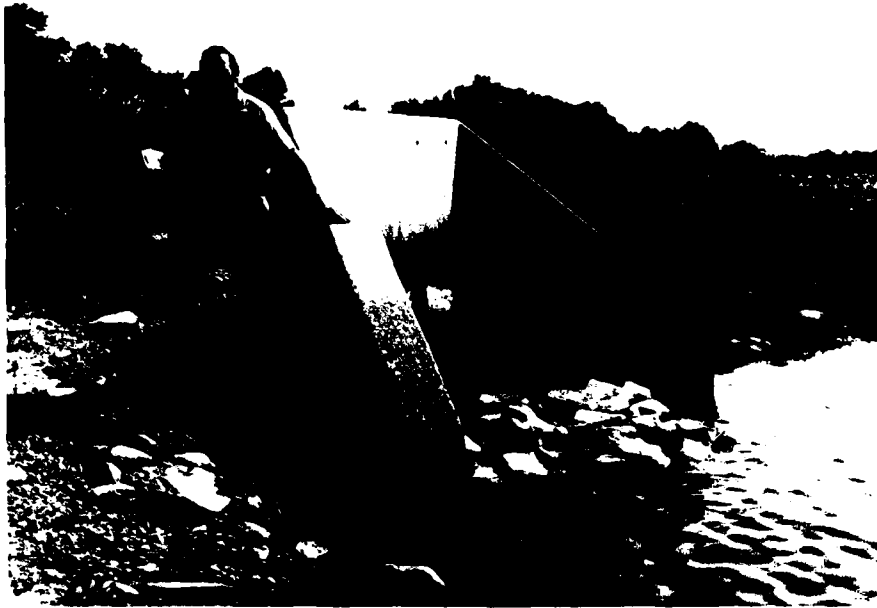
13. Outlet of 30-inch water intake from Segreganset River
